Autoguider repairs at Mount Wilson in 2014 April

TECHNICAL REPORT NO. 365

Steven J. Hale

2014 May 23

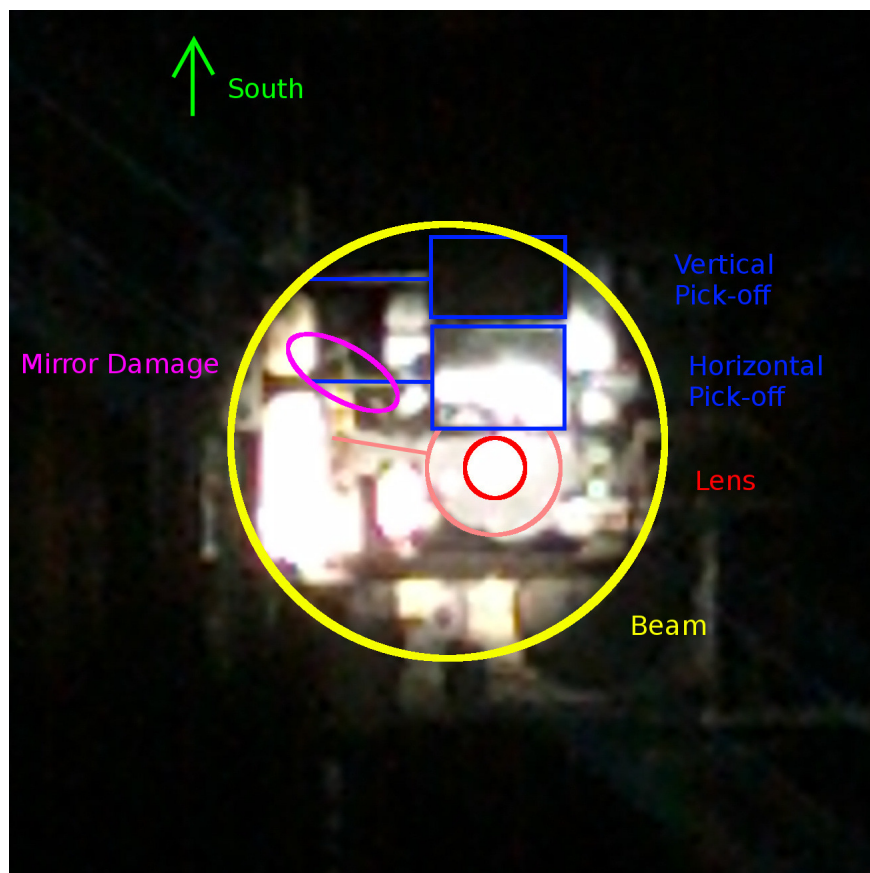
By looking down the tower from the top of the shaft, it is possible to see where the beam of light is falling at the bottom. The beam is currently not correctly centered on the objective lens, figure 1. It is biased to the south-east. The bias to the south is good because it means our pick-off mirrors are closer to the center of the beam. The bias to the east is not good, and the beam needs to be moved west to become more central. However, this can not be done because it would put the damaged part of the mirror directly over the area picked off by our mirrors.

Figure 1: Beam position, looking down the tower shaft.

In any case, it appears our pick-off mirrors are well illuminated. The beam would have to drift a long way for our spectrometer to experience vignetting. No adjustment to the guider-head position was made. This could be revisited once the first-flat has been repaired, and some improvement then made to the beam position.

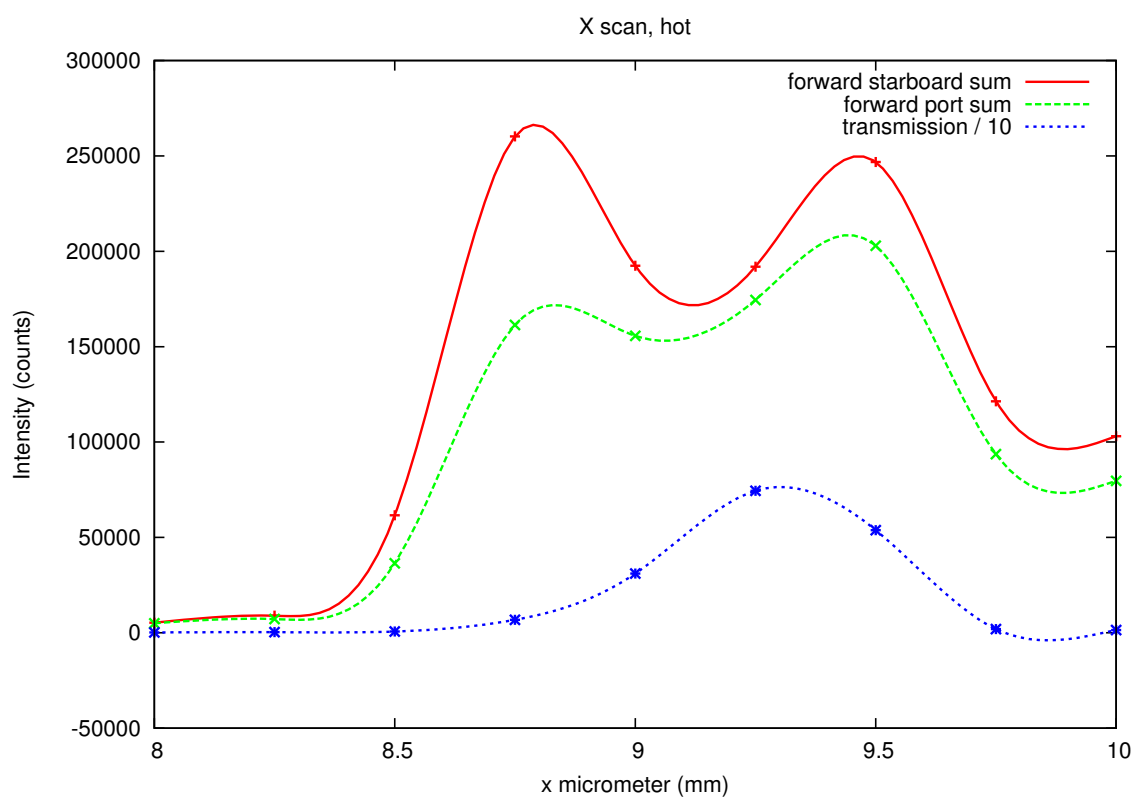
Later, a more quantitative alignment was performed by scanning the fifth-mirror in 0.25 mm increments and plotting the resulting data. These plots are shown in figures 2, 3, 4, and 5. These plots suggest that the basic alignment was almost perfect, with only a small change required on the x-micrometer.

The final settings were confirmed as 9.15 mm on the x-micrometer, and 5.85 mm on the y-micrometer. It is suggested that the basic visual alignment is sufficient for future trips.
